**APPENDIX B  
SUPPORTING DOCUMENTS**

**From:** Kevin McLeod [Kevin\_McLeod@gov.nt.ca]  
**Sent:** Wednesday, August 11, 2010 9:07 AM  
**To:** sdsmith1@telus.blackberry.net; Neil Cumming  
**Cc:** Stuart Smith  
**Subject:** RE: Deh Cho Bridge Phase 1 Audit

EBA Engineering Consultants Ltd. (EBA) was retained by Jivko Engineering to conduct an update geotechnical evaluation to confirm that the foundation conditions for the south four piers of the Deh Cho Bridge are consistent with findings during a prior geotechnical investigation. The objective of this evaluation was to conduct a drilling investigation on site in order to assess the subsurface soil conditions and to confirm that prior recommendations are still appropriate for the design and construction of the piers. This report presents the results of the follow-up geotechnical evaluation.

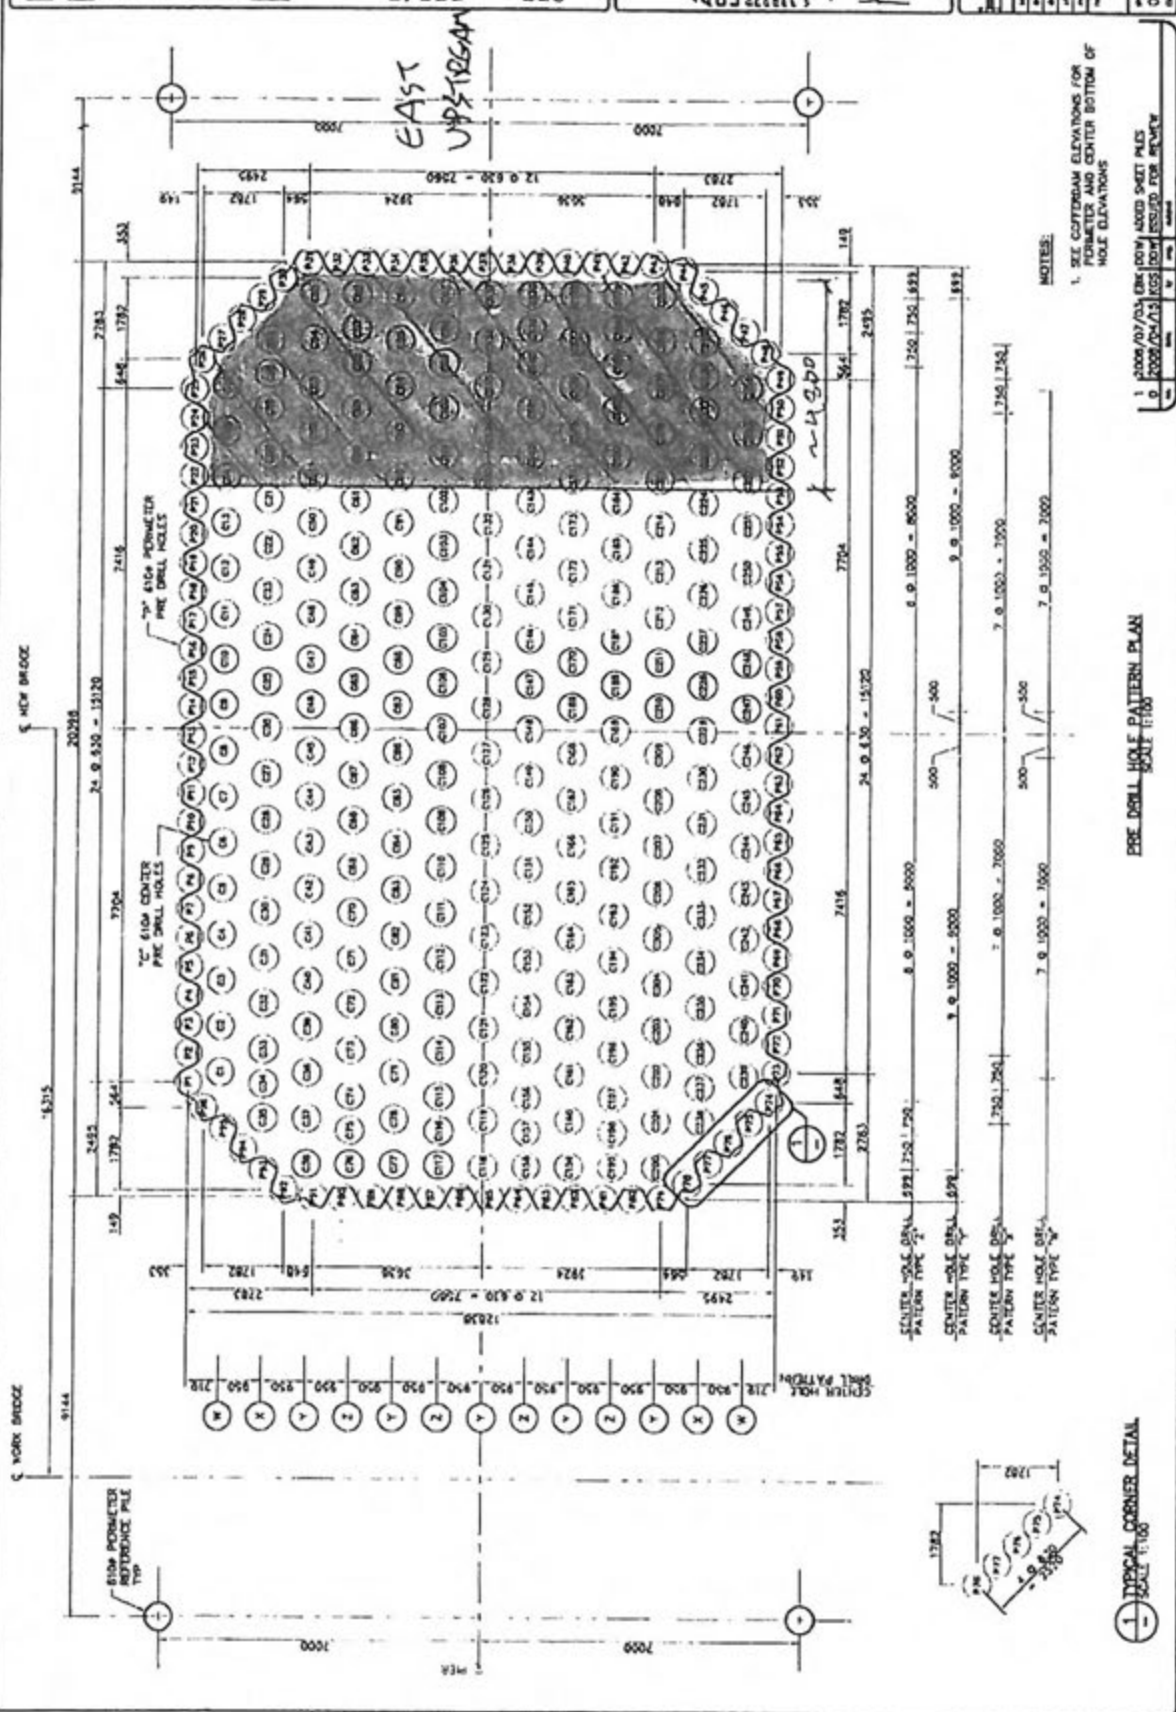
Sketch 2 Highlighted area drilled to elev 141.0m and excavated. The remaining area drilled and excavated to elev 142.5m.

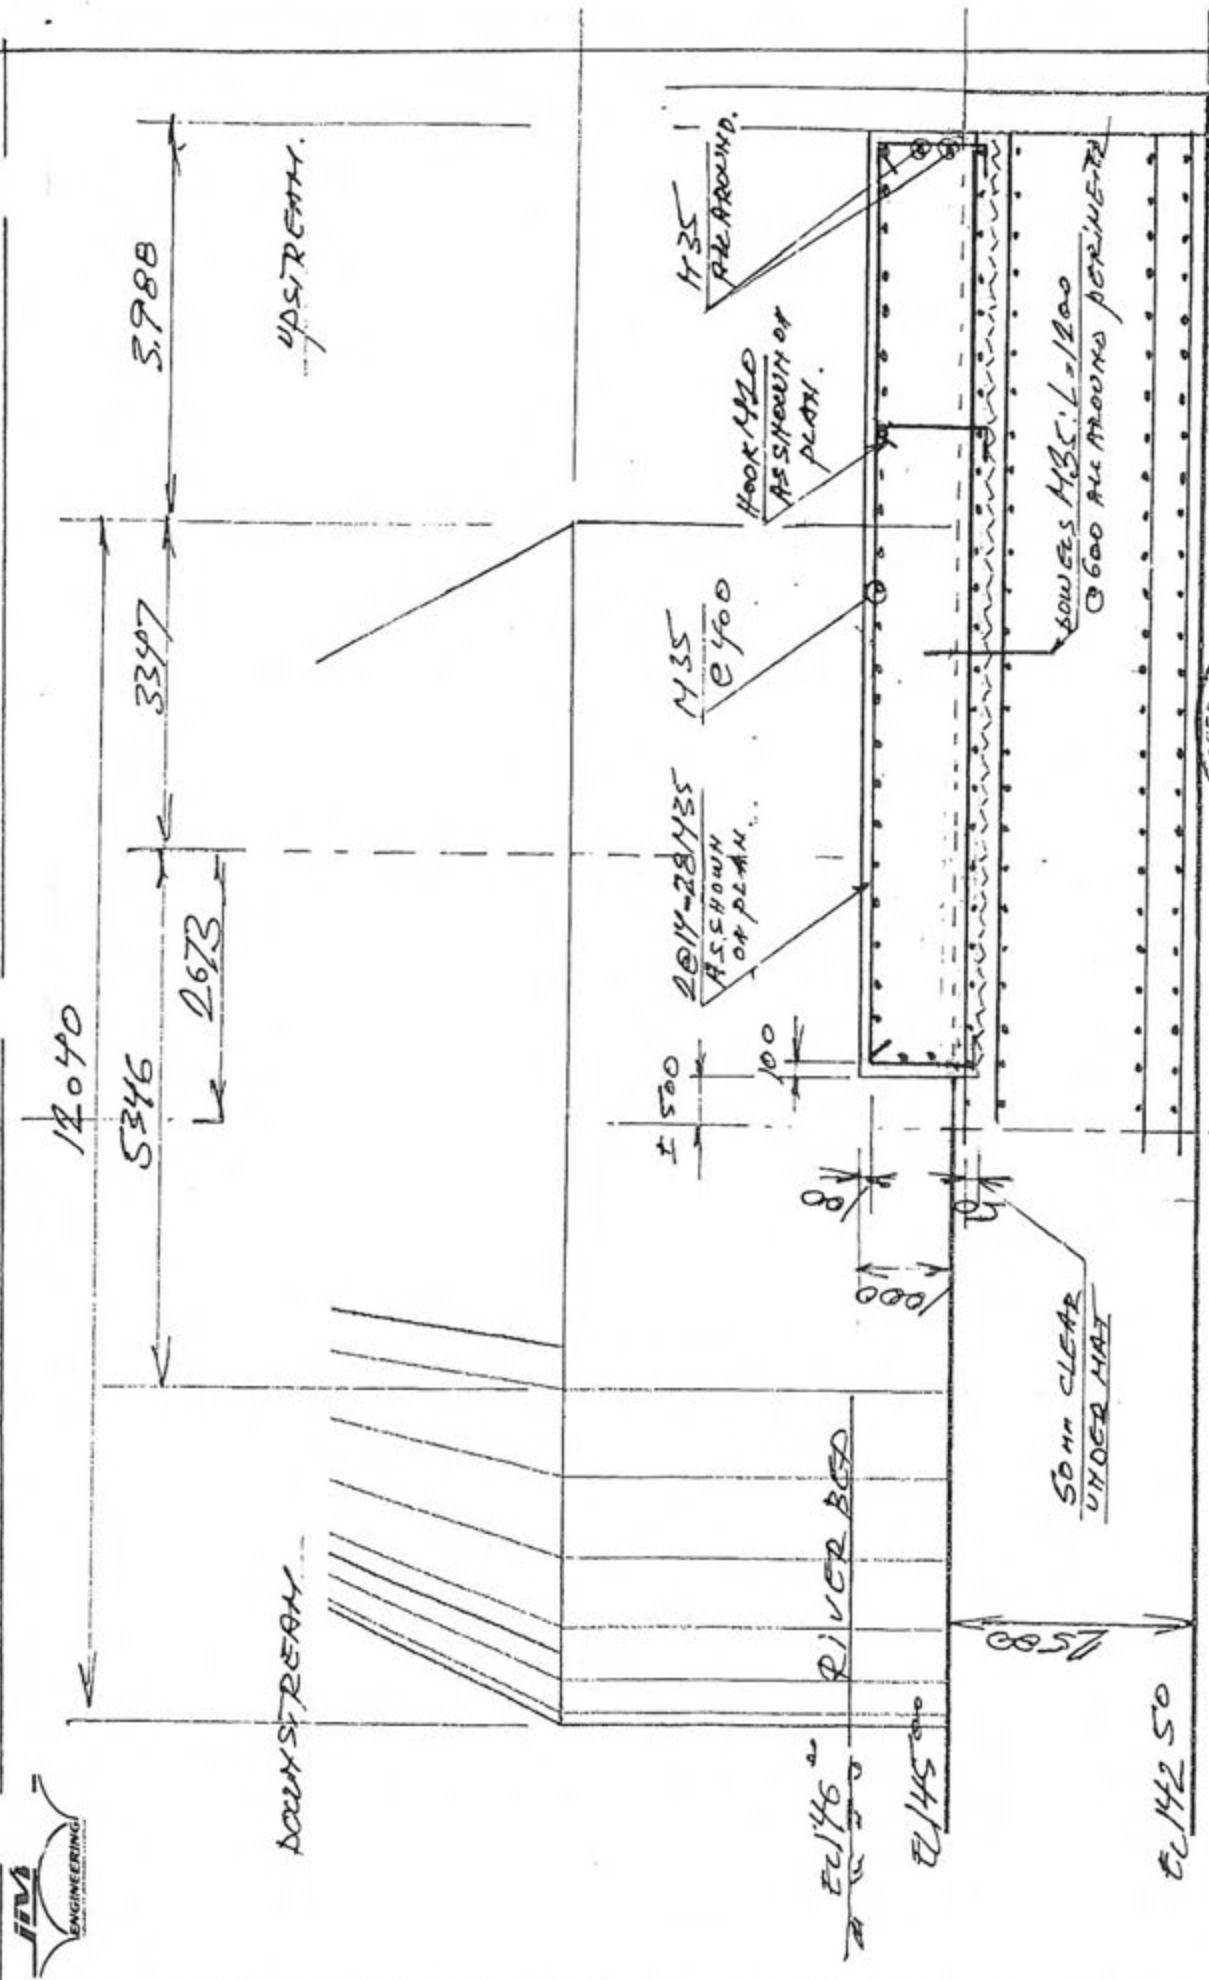
Frank,  
 Enclosed is design dwg 1 of 2 for the footing repair.  
 The GNWT design checker was unavailable to reply my comments so I decided to go for the more conservative option including M35 dowels on buttress wall and top of footing all around the perimeter of the area subject to repair.  
 Dwg 2 of 2, Plan has no substantial difference from the Prelim Design. I am working on it and will forward later in the afternoon.  
 With the enclosed drawing I hope you'll be able to start drilling holes and installing dowels. As agreed placing concrete shall not start before we have the Work Procedures accepted.

1. Concrete to be 35 MPa
2. Dowels to be M35; L=1,200, installed @600 on buttress wall and top of footing all around the perimeter of the repaired area.
3. Epoxy for dowels and bonding agent on the interface old/fresh concrete to be approved by the Engineer
4. Install 2" Styrofoam insulation covered with plastic sheet on the interface between sheet piling and fresh concrete

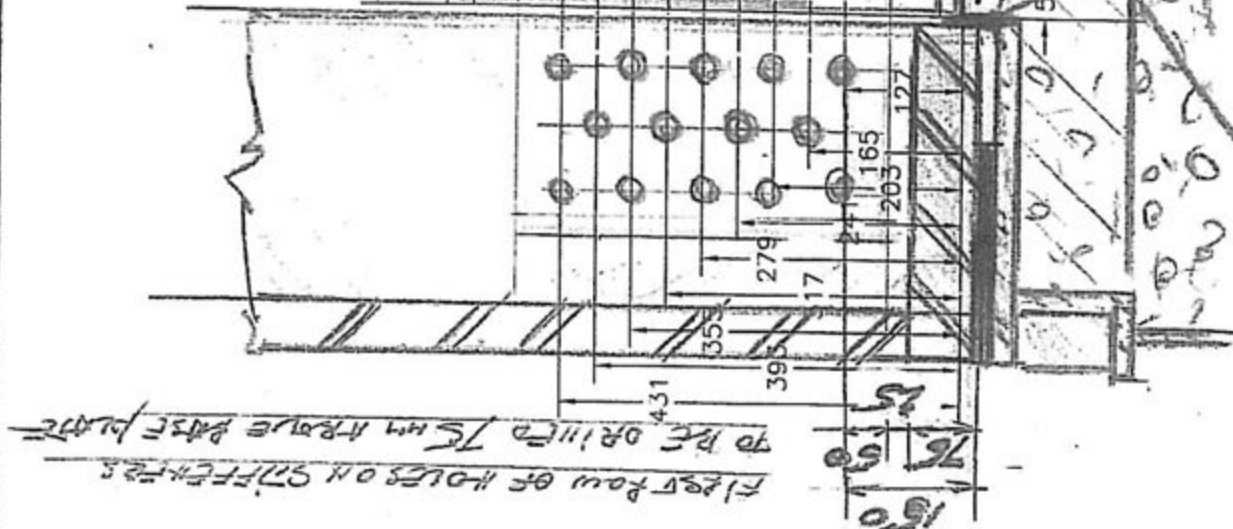
NOTE: IF ASSEMBLED "AS FABRICATED" THE  
BOTTOM FLANGE OF BEAM WOULD RESULT 25mm  
ABOVE THE DECK BASE PLATE.  
THIS ARRANGEMENT WOULD REQUIRE INCREASE  
OF THE SUPPORTING CONCRETE LAYER BY 25mm.

Two Beams with  
holes incorrectly  
drilled to  
dimensions to  
bottom of flange

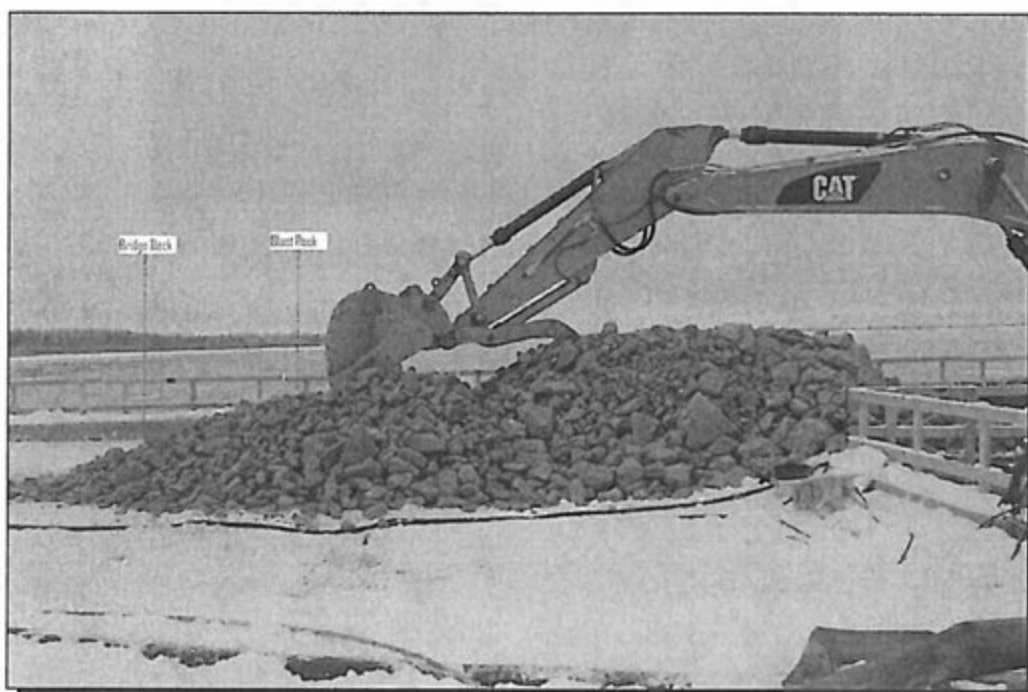
**Photo 4**  
Blast rock delivered to Pier 2 South, on the temporary bridge deck.

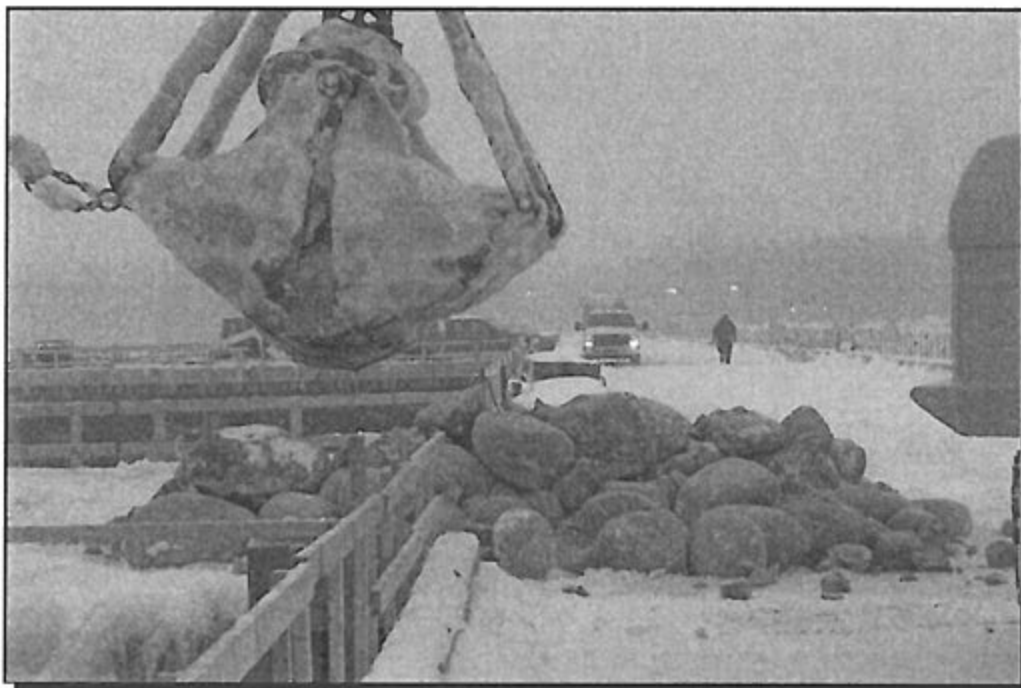
**Photo 4**  
Buckets attached to crane for placing the scour rock into the cofferdam

EBA monitored the placement of some material at Pier 2 south. The material was dumped on the temporary bridge deck. From there it was dropped about 7.5 m to the surface of the footing. The material was then distributed with a Bobcat. The handling during placing resulted in some breaking up of the material. So the material in place was somewhat finer than in the stockpile.

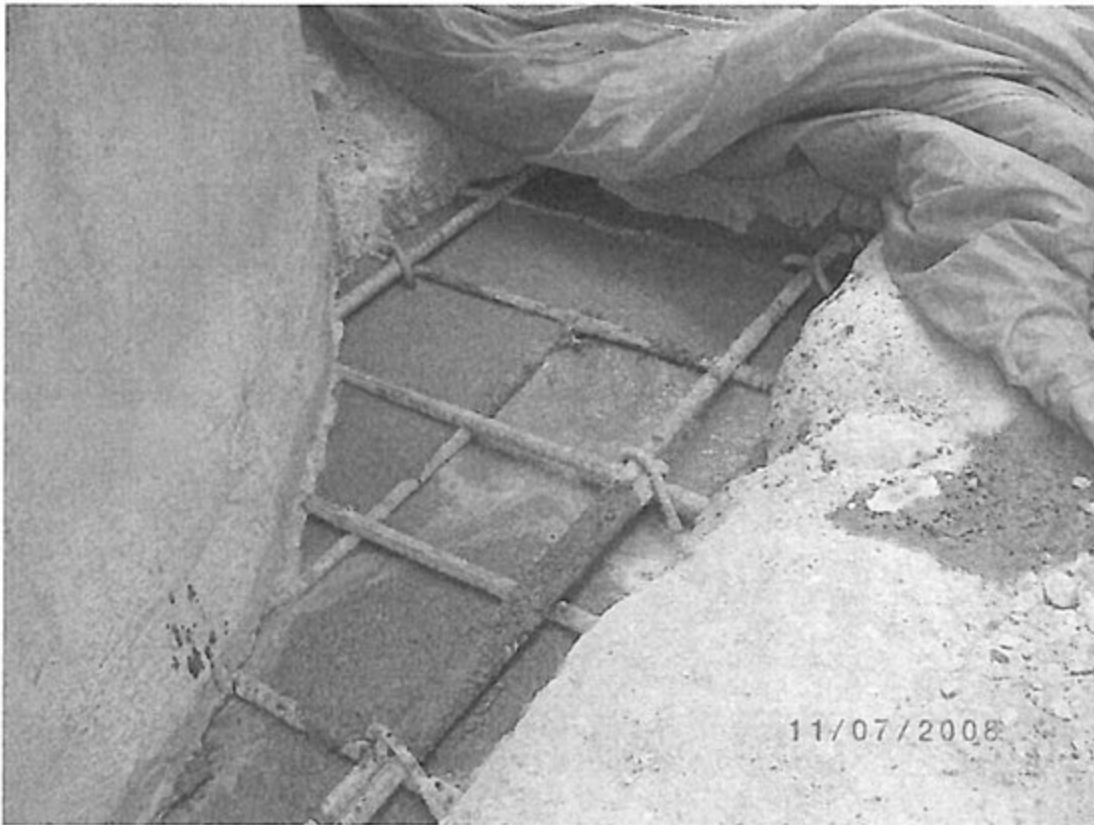
In an email of May 9, 2010 Mr. Whiteman provided four photos of the area where repairs were allegedly not carried out, however on review it was found that the photos did not show the area of concern. One photo (Photo 1 below) dated November 7, 2008 showed a depression with exposed rebar partially filled with fresh concrete. This is a significant photo and will be referred to below.

**Photo 1:** Depression partially filled with fresh concrete, November 7, 2008. This could be either the southeast or northwest corner of the Lower Buttress.

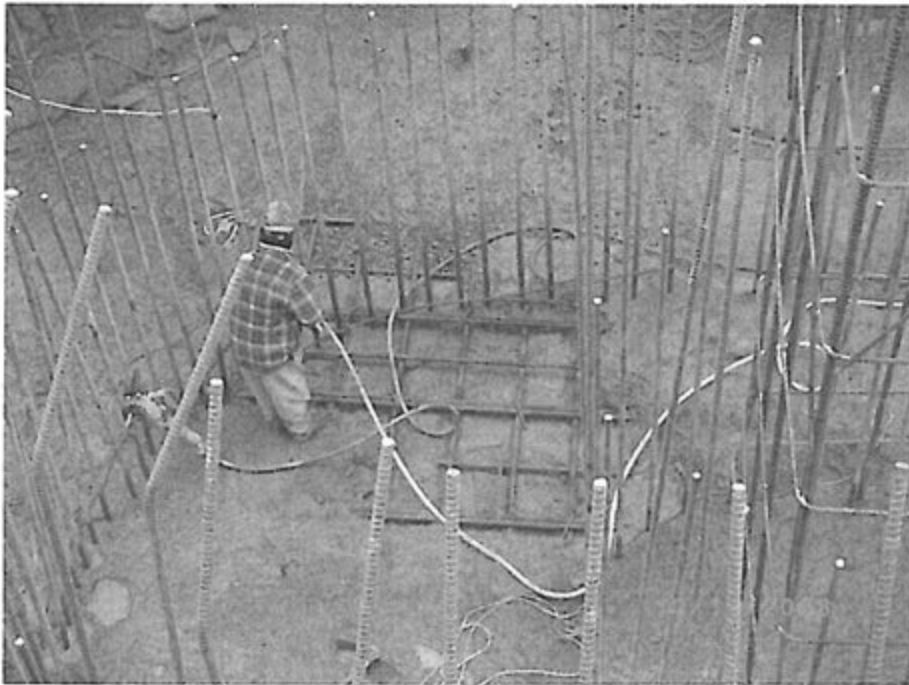
Two other photos dated October 17, 2008 (Photos 2 and 3) showed concrete removal in progress where the top rebar was exposed. The area shown is primarily inside the dowels for the lower buttress, and extends slightly outside this area. However the location shown does not correlate with Mr. Whiteman's verbal description of the location of the unrepaired depression.

**Photo 2:** Concrete removal in progress, October 17, 2008. Note that the depression extends outside the dowels for the lower buttress. This could be either the northwest or southeast corner.

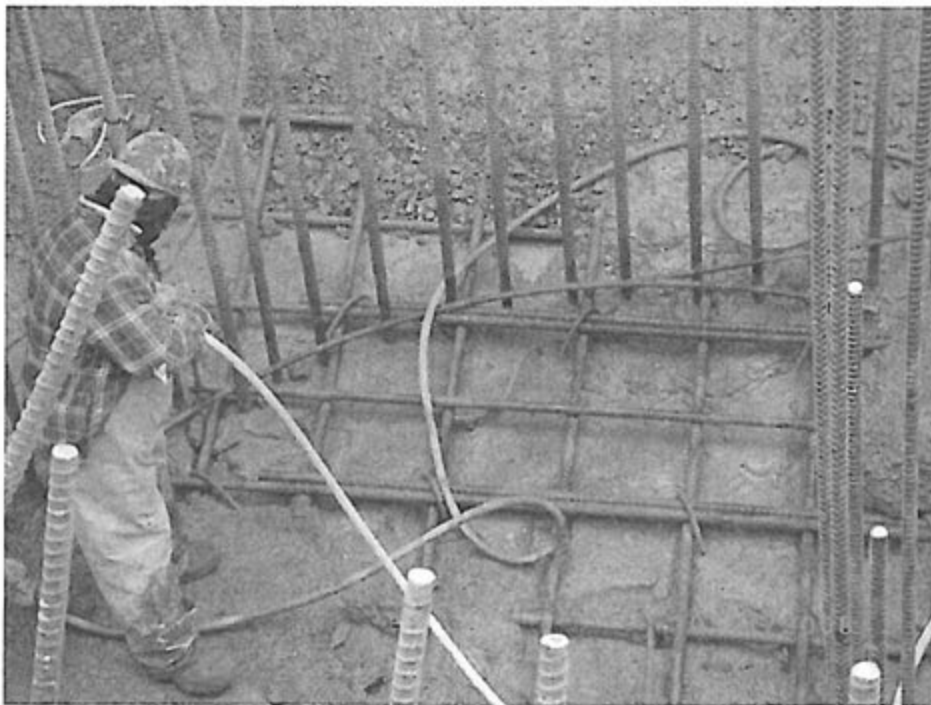
**Photo 3:** Close up of area shown in Photo 2.

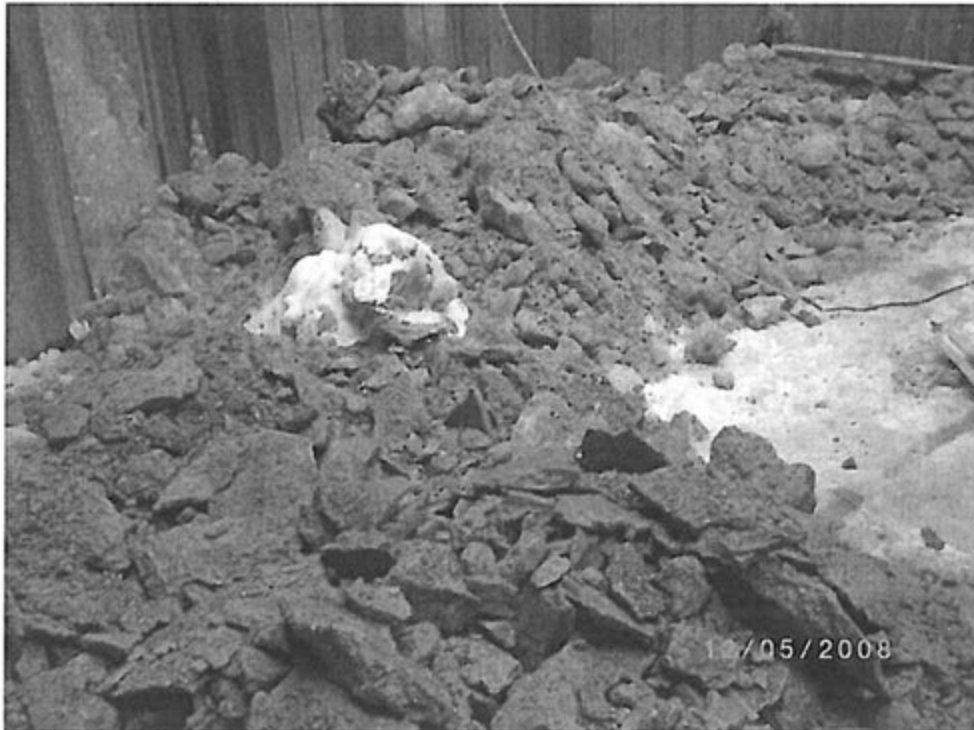
A fourth photo, dated December 5, 2008 shows broken concrete and debris piled on top of the footing against the cofferdam. It is difficult to tell where this area is in relation to the allegedly unrepaired areas. Again, the date of this photo is significant as will be discussed below.

**Photo 4:** Debris piled against cofferdam, December 12, 2008.

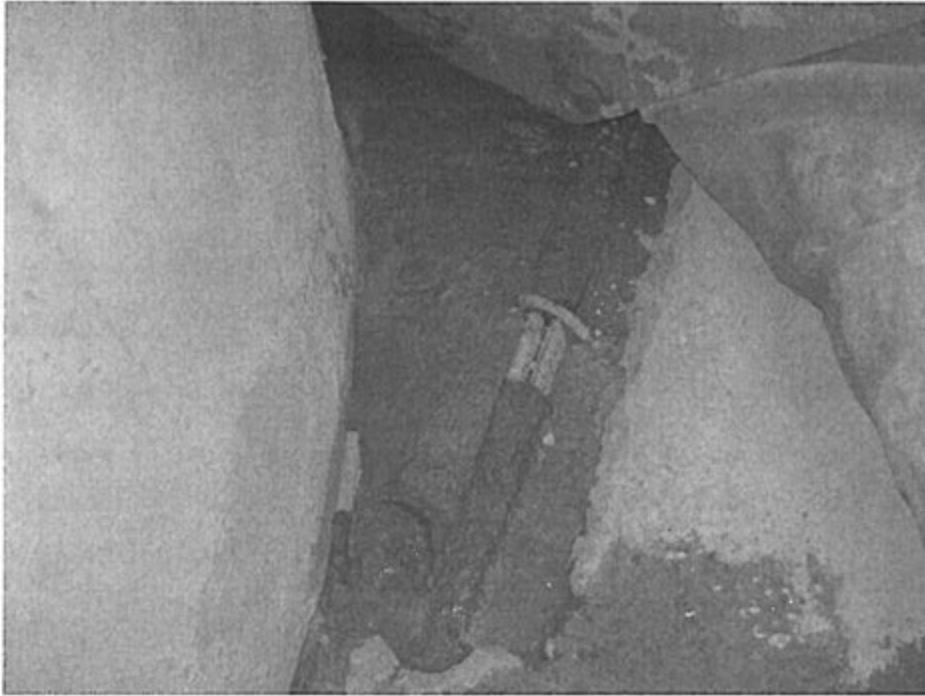
Hence, it appears that the depression near the northwest corner of the lower buttress was filled on November 7, 2008. Photo 5, provided by Mr. Lagerquist, was taken on November 7, 2008 and shows a depression partially filled with fresh concrete. Photo 6 shows the depression against the cofferdam on November 12, 2008, indicating that it was not filled at the same time.

**Photo 5:** Depression partially filled with fresh concrete, November 7, 2008. This appears to be the same area shown in Photo 1.

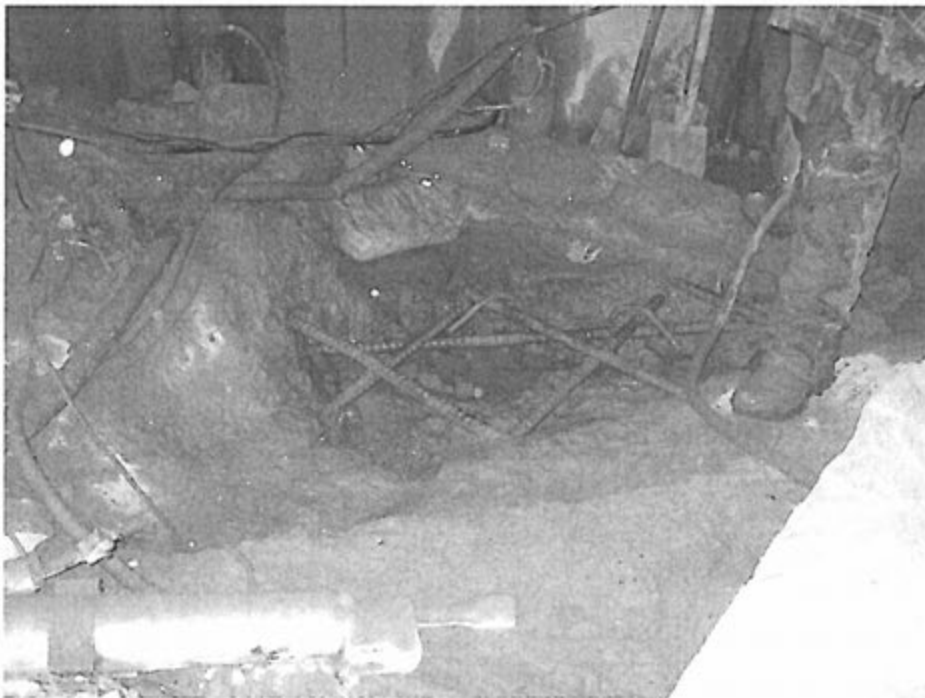
**Photo 6:** Depression near cofferdam, November 12, 2008.
