**APPENDIX B  
SUPPORTING DOCUMENTS**

**From:** Kevin McLeod [Kevin\_McLeod@gov.nt.ca]  
**Sent:** Wednesday, August 11, 2010 9:07 AM  
**To:** sdsmith1@telus.blackberry.net; Neil Cumming  
**Cc:** Stuart Smith  
**Subject:** RE: Deh Cho Bridge Phase 1 Audit

EBA Engineering Consultants Ltd. (EBA) was retained by Jivko Engineering to conduct an update geotechnical evaluation to confirm that the foundation conditions for the south four piers of the Deh Cho Bridge are consistent with findings during a prior geotechnical investigation. The objective of this evaluation was to conduct a drilling investigation on site in order to assess the subsurface soil conditions and to confirm that prior recommendations are still appropriate for the design and construction of the piers. This report presents the results of the follow-up geotechnical evaluation.

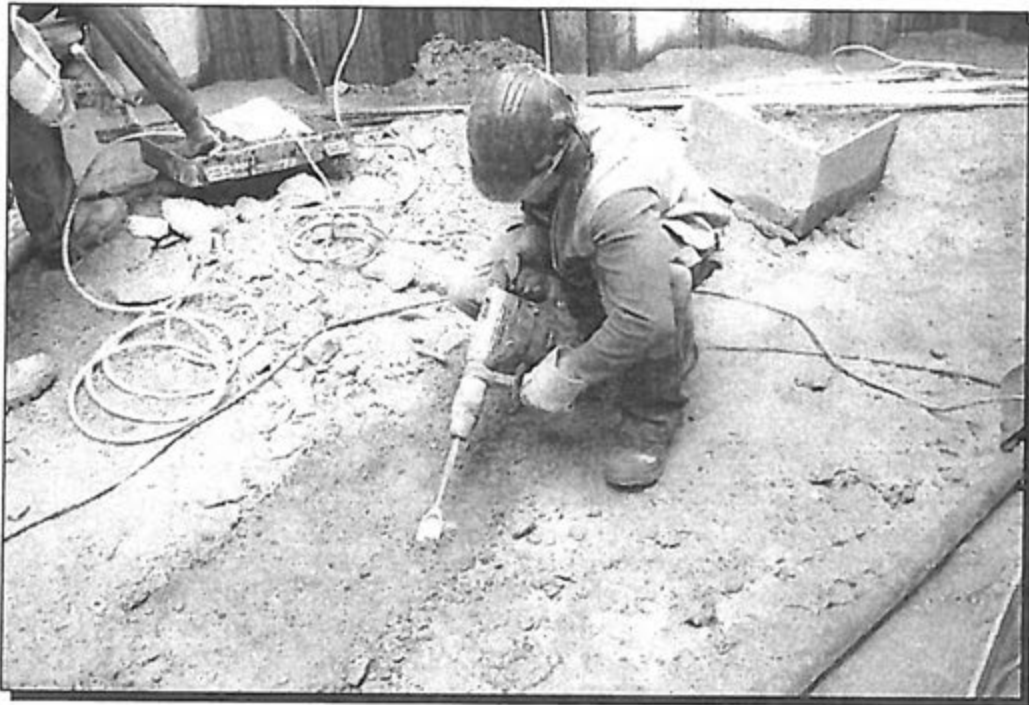
**Photo 3**  
Pier 1 (preparing footing for drilling)

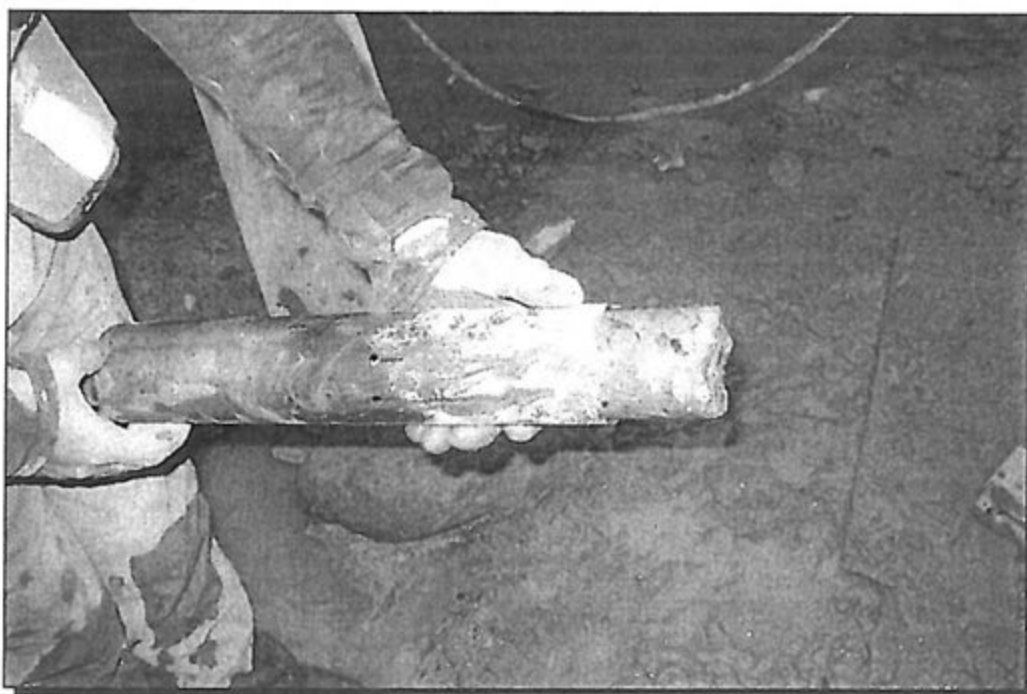
**Photo 6**  
Pushing out concrete core

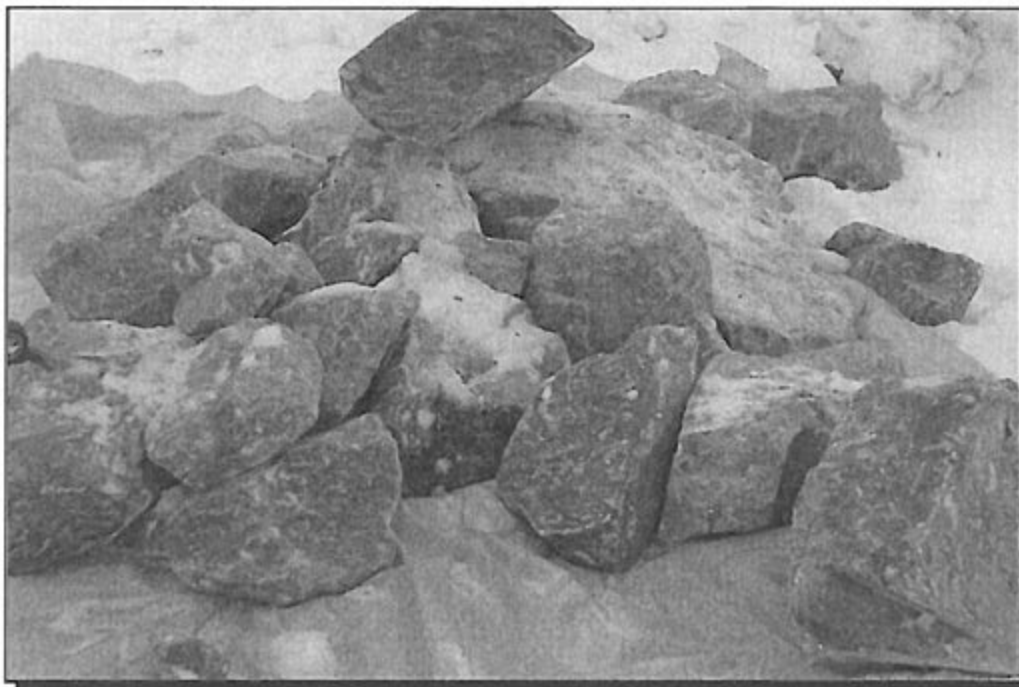
**Photo 1**  
Blasted granite placed on tarp for gradation test

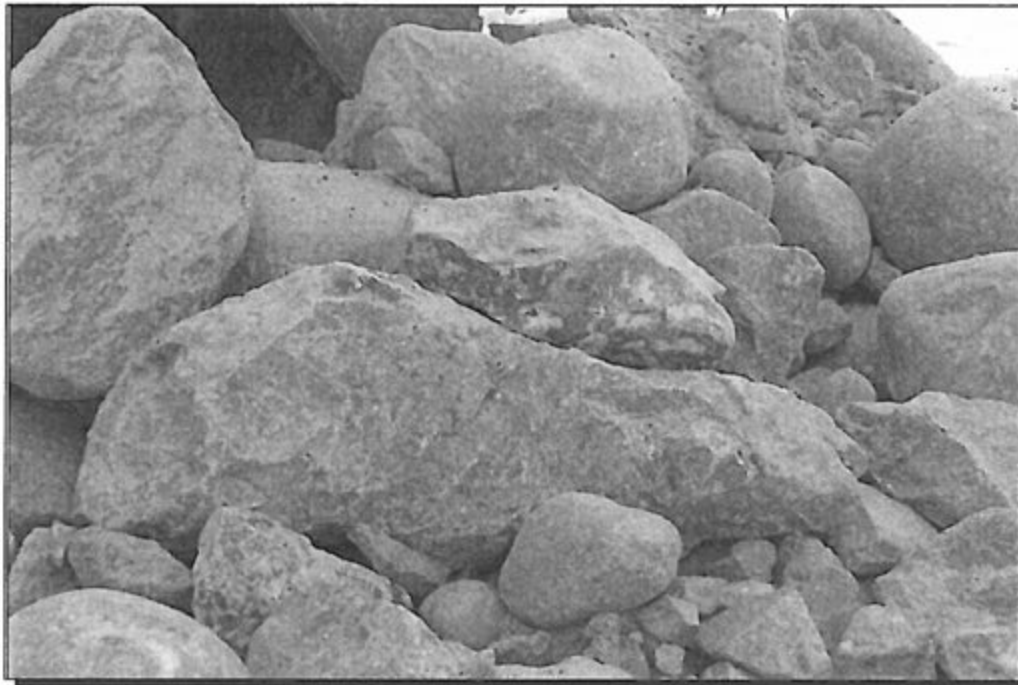
**Photo 3**  
Mixture of round rock and blasted granite ready for placement at bridge site
