**APPENDIX B  
SUPPORTING DOCUMENTS**

**From:** Kevin McLeod [Kevin\_McLeod@gov.nt.ca]  
**Sent:** Wednesday, August 11, 2010 9:07 AM  
**To:** sdsmith1@telus.blackberry.net; Neil Cumming  
**Cc:** Stuart Smith  
**Subject:** RE: Deh Cho Bridge Phase 1 Audit

EBA Engineering Consultants Ltd. (EBA) was retained by Jivko Engineering to conduct an update geotechnical evaluation to confirm that the foundation conditions for the south four piers of the Deh Cho Bridge are consistent with findings during a prior geotechnical investigation. The objective of this evaluation was to conduct a drilling investigation on site in order to assess the subsurface soil conditions and to confirm that prior recommendations are still appropriate for the design and construction of the piers. This report presents the results of the follow-up geotechnical evaluation.

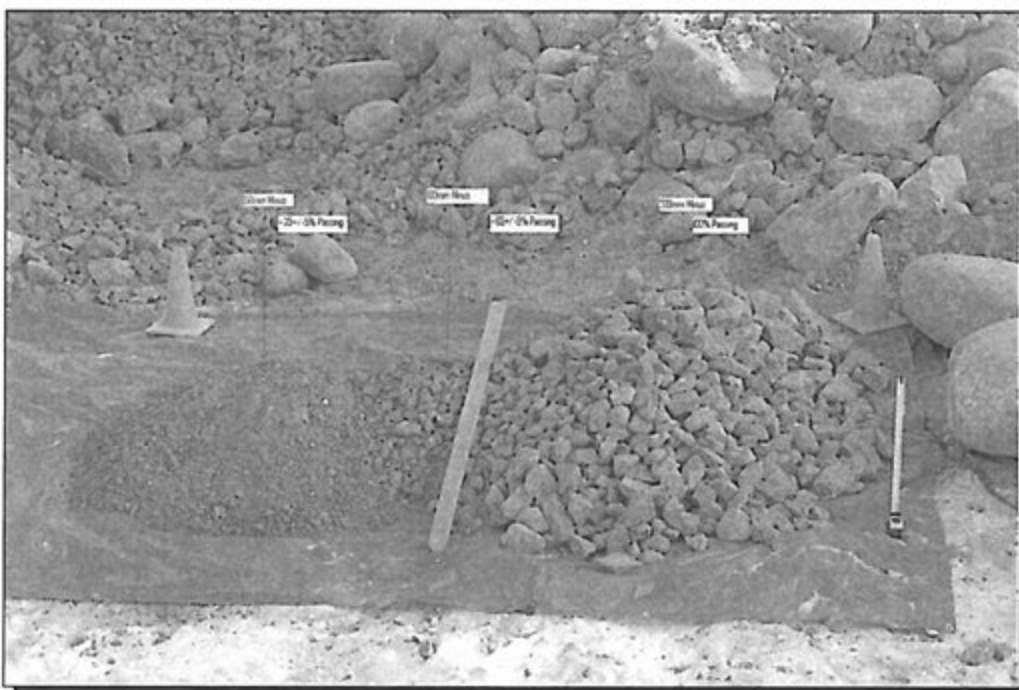
The second sample to be tested was the blast rock from km 155 along Highway 3. One subsample was collected from the pile with a Cat 330 excavator. A second subsample was collected from the opposite side of the stockpile, in an effort to collect a representative sample. The subsamples were placed on a blue plastic tarp. The material was arranged by size (Photo 2). The visually assessed results are presented on Table 1.

**Photo 2**  
Blast rock sorted by size

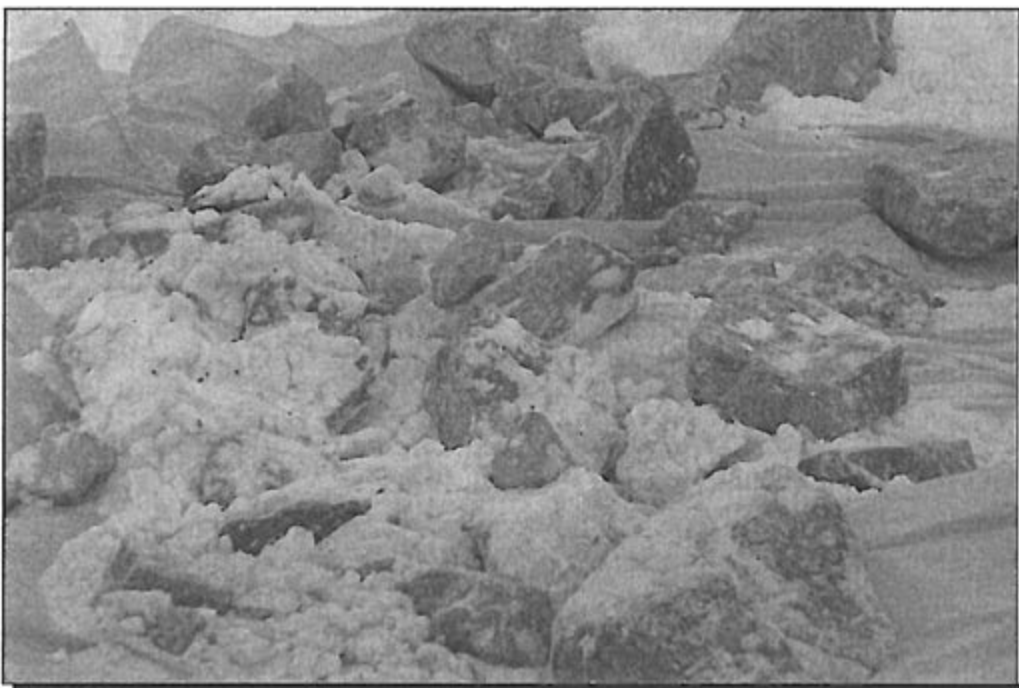
**Photo 2**  
Blasted granite spread out and sorted according to size
